Manhole Inspection Summary

Manhole # S21G__061MH

Insp Date: **8/28/07 6:14 AM**

Location Address: **1 FULTON AVE**

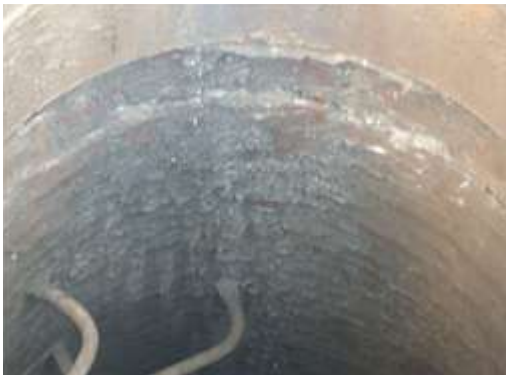
Defect 2

Infiltration: ☐ None ☐ Joint ☐ Cracks ☐ Mortar ☐ Roots ☒ **Wall**

INFILTRATION OF CHIMNEY

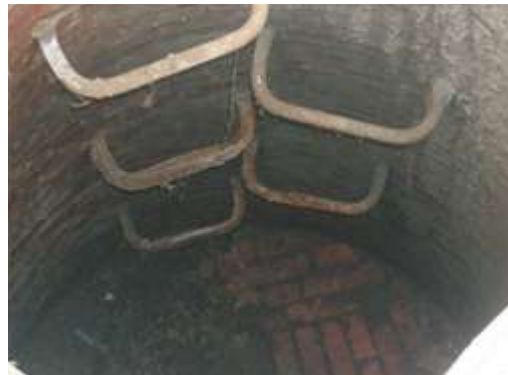
Defect 1

Steps Count: **5** Missing: **0** ☒ **Corroded**

CORRODED STEPS

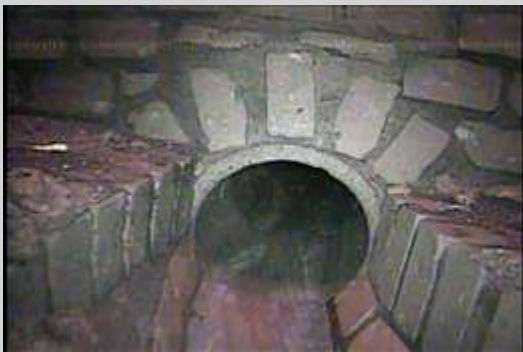
12 O'Clock Outflow

8 in. Circular Gravity Sewer
Pipe Out @ 12 O'Clock

Pipe Height: **7.2** (in.) Rod and Bar (Angled)
Pipe Material: **Clay** ☐ Pipe Lined
Invert Depth: **10.12** (ft.) Flow Characteristics: **Slow**
Deposits: ☒ None ☐ Mud ☐ Sludge ☐ Debris ☐ Grease
Silt Depth: (in.) Deposits Extent:
Infiltration: **None** Pipe Seal Cond: **Sound**

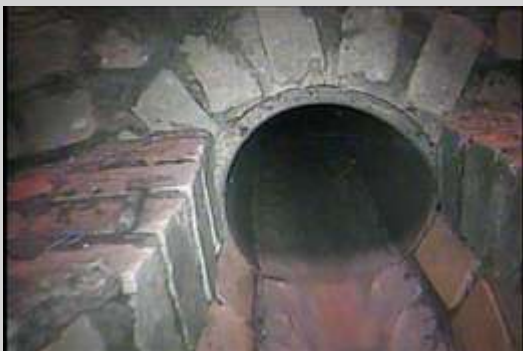
4 O'Clock Inflow

8 in. Circular Gravity Sewer
Pipe In @ 4 O'Clock

Pipe Height: **8.4** (in.) Rod and Bar (Angled)
Pipe Material: **Clay** ☐ Pipe Lined
Invert Depth: **9.93** (ft.) Flow Characteristics: **Slow**
Deposits: ☒ None ☐ Mud ☐ Sludge ☐ Debris ☐ Grease
Silt Depth: (in.) Deposits Extent:
Infiltration: **None** Pipe Seal Cond: **Sound**
